Inspection Report Minerals Regulatory Program February 3, 2010

Mine Name: Bonanza	Permit Number: M/047/0010
Operator Name: American Gilsonite	Inspection Date: November 4, 2009
Inspector(s): L Heppler	Time: 3:00 pm
Other Participants: Valynn Davis- American Gilsonite	Mine Status: Active

Purpose of Inspection: Routine annual Inspection. This site was inspected as a large mine site on 10/31/2006

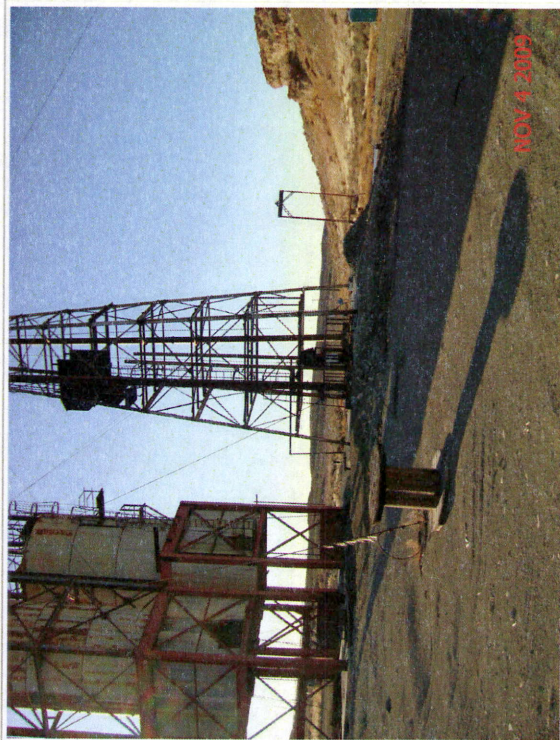
Inactive site, still needs reclamation

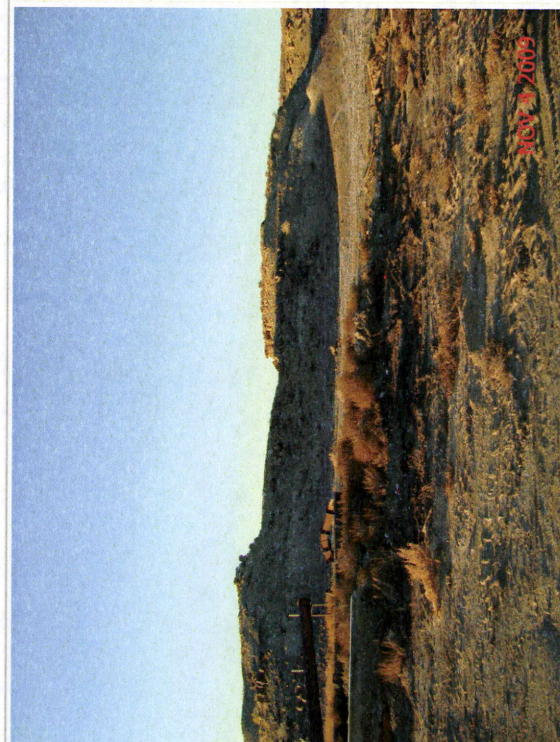
Site undergoing reclamation

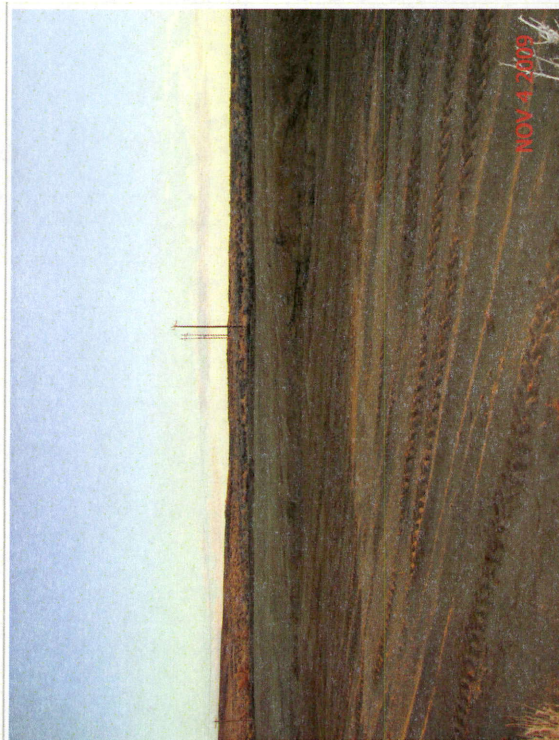
Reclaimed site - Ground should be roughed prior to seeding

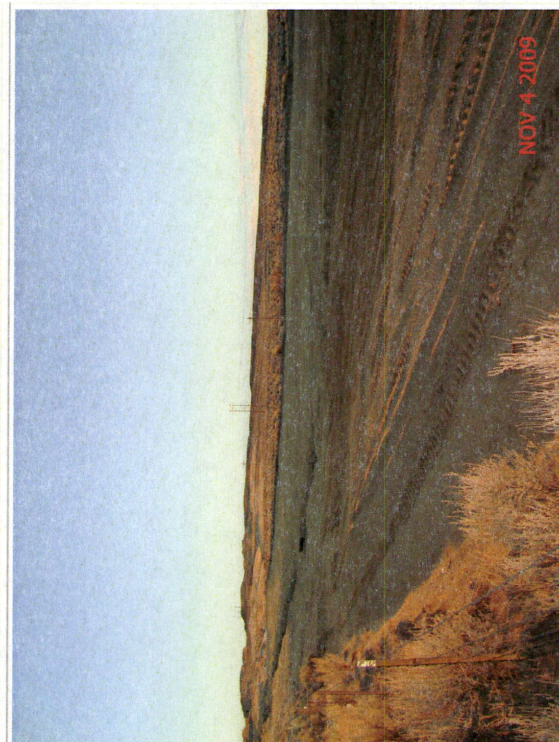
Large area of reclamation
